Roadtrains in Norway

Norges
Lastebileier-Forbund

- Practical experience from driving roadtrains in Norway shows that accidents happen due to the construction of the typical EU-roadtrain
- Examples of situations causing damage or accidents
- Our solutions

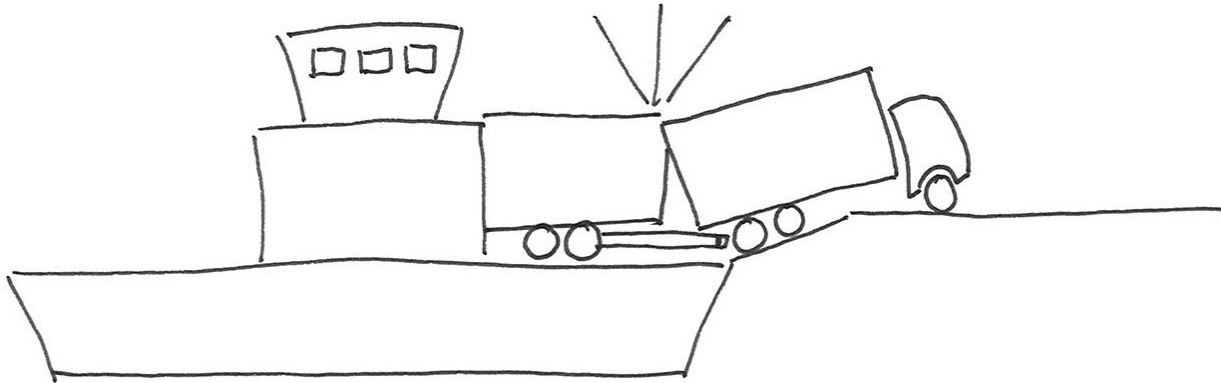
Damage on load

- In areas where there is a depression in the ground
- On and off ferries
- The upper corners of the load are destroyed

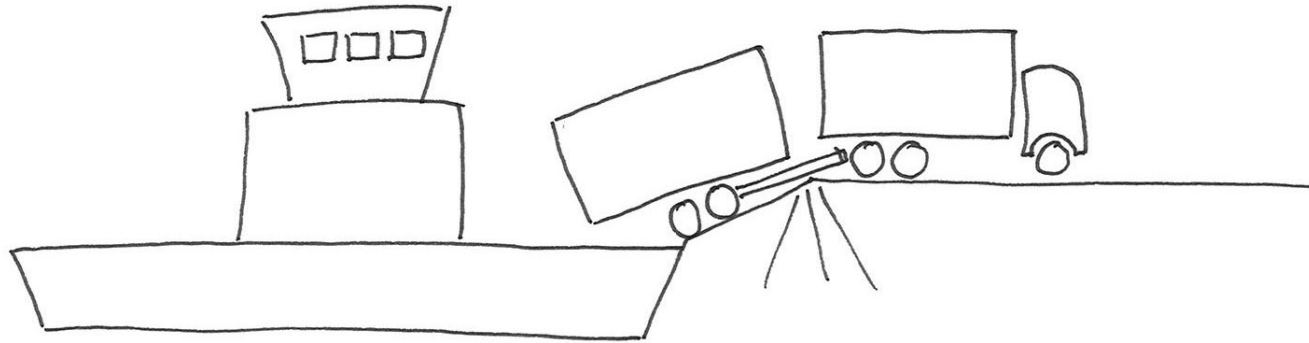
Damage on vehicles

- In areas where the road goes over a hillock
- On and off ferries
- The drawbar of the piggyback trailer is destroyed

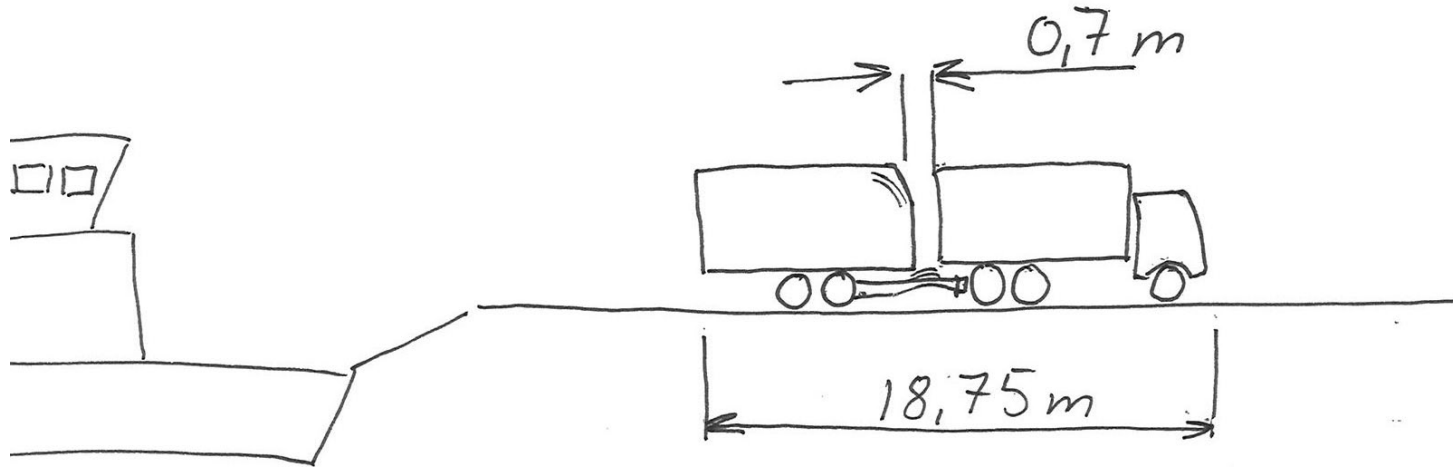
EU-roadtrain

- Dimensions of the EU roadtrain are causing accidents and damage to the vehicles on Norwegian roads

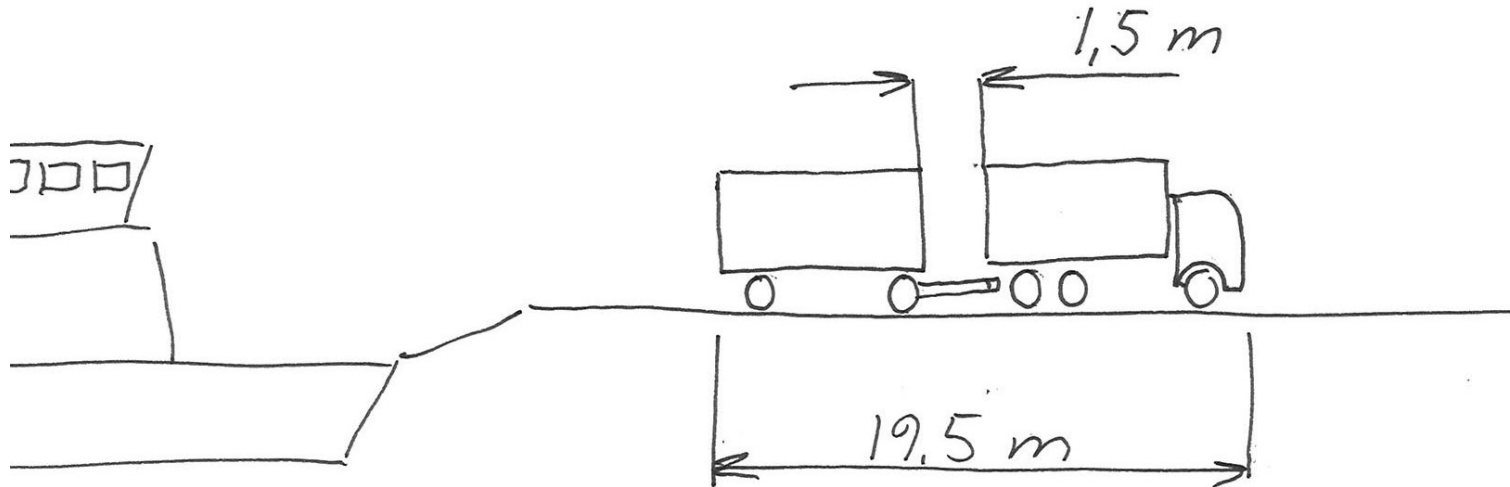
Solution

- Drawbar trailer with larger distance to the truck and better ground clearance under the drawbar has less problems
- No damage to the equipment in depressions or over hillocks

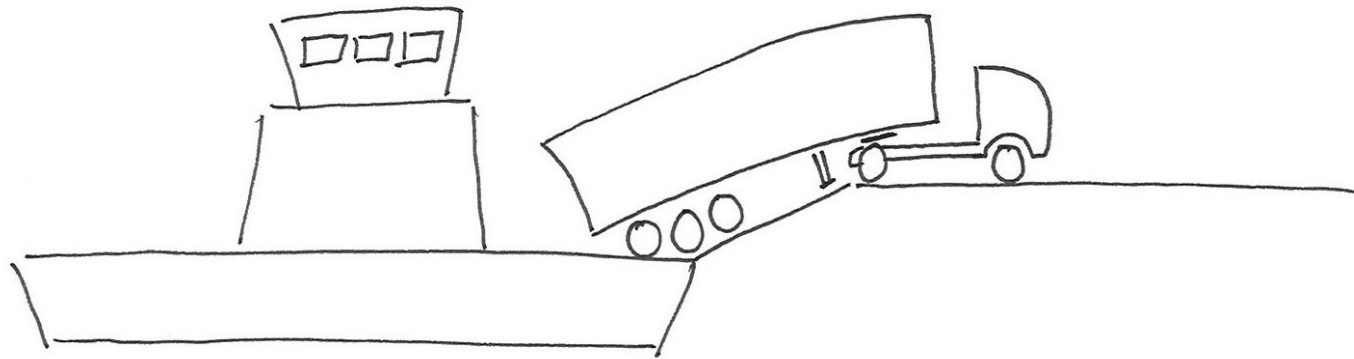
Roadtrain with semitrailer

Using the typical 2 axle EU tractor is not recommended, especially during winter-time in Norway

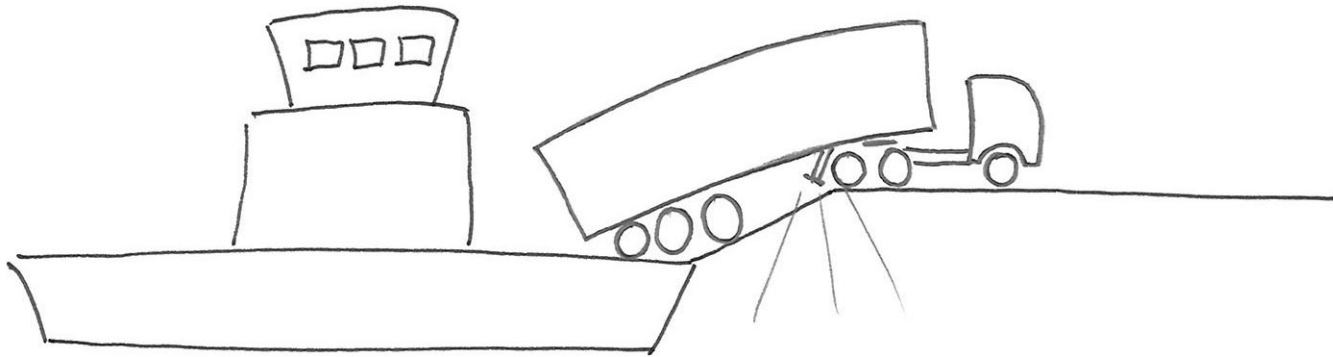
3 axled Tractors

When using Norwegian 3 axled tractors, damage often occurs when the vehicles are coupled-up within a total length of 16,5 meter

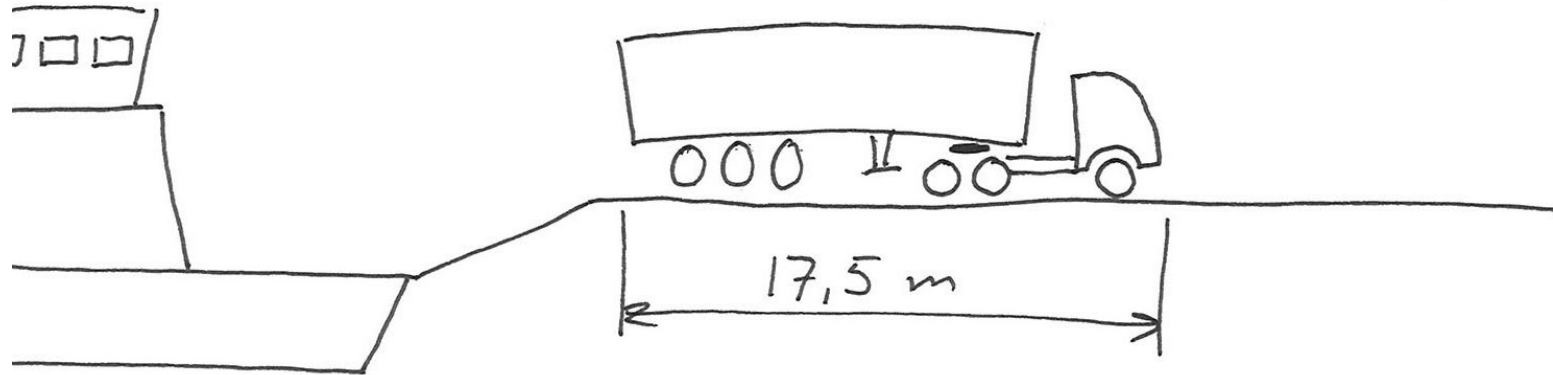
Solution

3 axle tractor with semitrailer needs larger distance between tractor and semitrailer to prevent damage

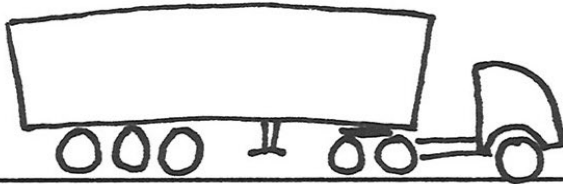
Loading length remains

Norwegian 17,5 meter

EU 16,5 meter

Tractor with 3 axles
in Norway

Tractor with 2 axles
in the EU

Loading length of 13,6 meters remains the same

In order to pull the same loading length safely the
Norwegian roadtrain must be 17,5 meter

In order to transport the EU loading lengths of directive 96/53 under safe conditions, roadtrains in Norway must be slightly longer than in the EU: 19,5 meter and 17,5 meter
